Manhole Inspection Summary

Manhole # S33M1_001MH

Location Address: **3026 Seamon Ave.**

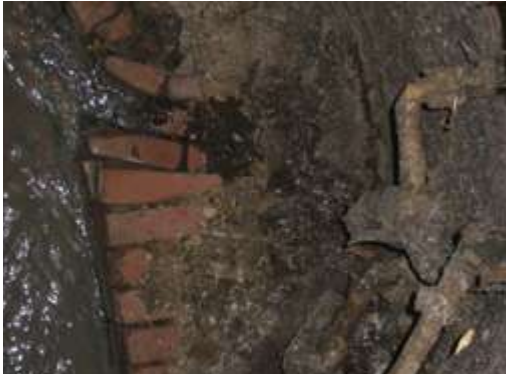
Defect 2

Bench ☒ Exists Material: **Brick** ☐ Parged

Condition: ☐ Sound ☐ Cracked ☐ Root Intrusion ☐ Deteriorated ☐ Leaks ☒ **Debris**

Bench

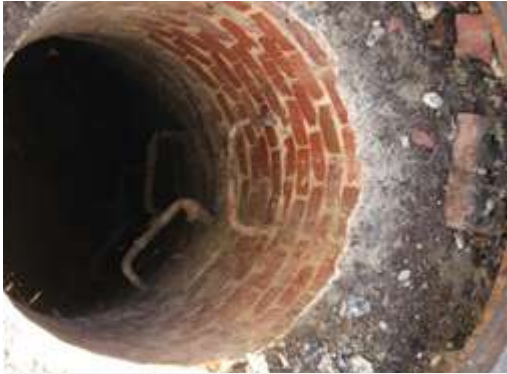
Defect 1

Chimney / Frame Adjustment ☒ Exists Material: **Brick** ☐ Parged Height: **4** (in.)

Condition: ☐ Sound ☐ Cracked ☐ Root Intrusion ☒ **Loose Brick** ☐ Deteriorated

Infiltration: ☐ None ☐ Joint ☐ Cracks ☐ Mortar ☐ Roots ☒ **Wall**

Chimney

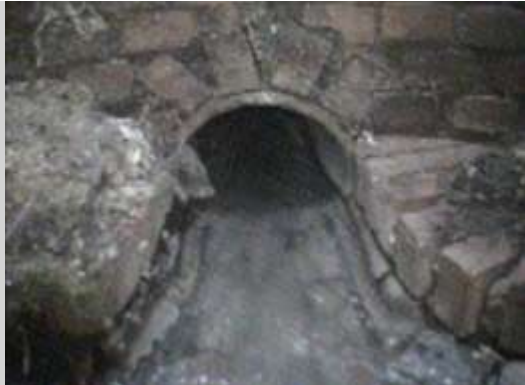
12 O'Clock Outflow

10 in. Circular Gravity Sewer
Pipe Out @ 12 O'Clock

Pipe Height: **12** (in.) Rod and Bar (Angled)
Pipe Material: **Clay** ☐ Pipe Lined
Invert Depth: **11.32** (ft.) Flow Characteristics: **Fast**
Deposits: ☒ None ☐ Mud ☐ Sludge ☐ Debris ☐ Grease
Silt Depth: (in.) Deposits Extent:
Infiltration: **None** Pipe Seal Cond: **Sound**

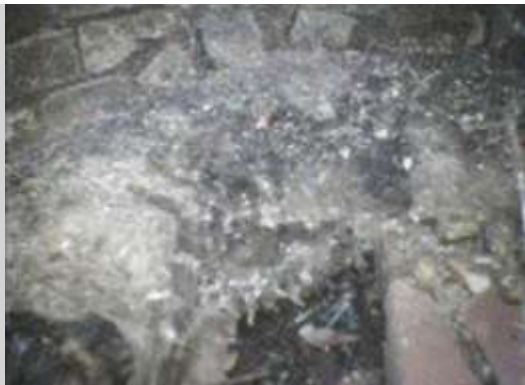
3 O'Clock Inflow

Comments **Unable to obtain measurements for influent pipes @ 3 O'clock and 9 O'clock due to debris.**

4 in. Circular Gravity Sewer
Pipe In @ 3 O'Clock

Pipe Height: **3.6** (in.) Rod and Bar (Angled)
Pipe Material: **Clay** ☐ Pipe Lined
Invert Depth: **2.00** (ft.) Flow Characteristics: **None**
Deposits: ☐ None ☒ **Mud** ☐ Sludge ☐ Debris ☐ Grease
Silt Depth: **10** (in.) Deposits Extent: **Heavy**
Infiltration: **None** Pipe Seal Cond: **Unknown**

Connects To: **Stub connection / abandoned**

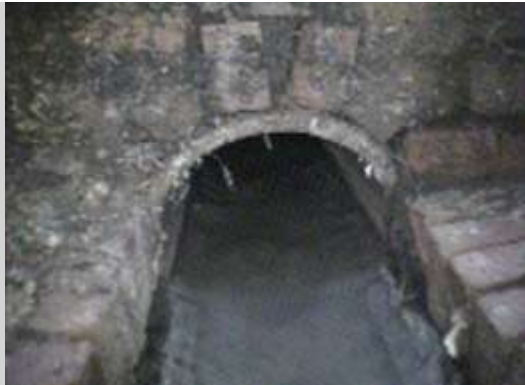
6 O'Clock Inflow

10 in. Circular Gravity Sewer

Pipe In @ 6 O'Clock

Pipe Height: **12** (in.) Rod and Bar (Angled)

Invert Depth: **11.13** (ft.) Flow Characteristics: **Fast**

Infiltration: **None** Pipe Seal Cond: **Sound**

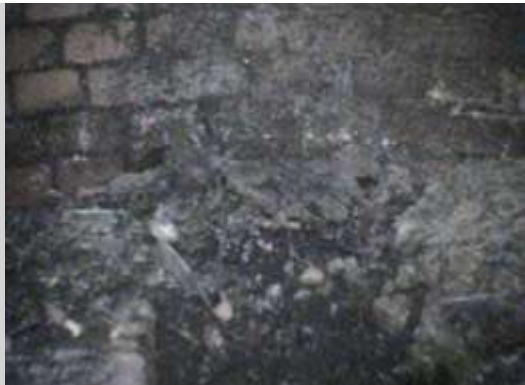
9 O'Clock Inflow

4 in. Circular Gravity Sewer

Pipe In @ 9 O'Clock

Pipe Height: **3.6** (in.) Rod and Bar (Angled)

Deposits: ☐ None ☒ **Mud** ☐ Sludge ☐ Debris ☐ Grease

Silt Depth: **10** (in.) Deposits Extent: **Heavy**

Connects To: **Stub connection / abandoned**
